Surface Inhibition/Wash Slow Setting

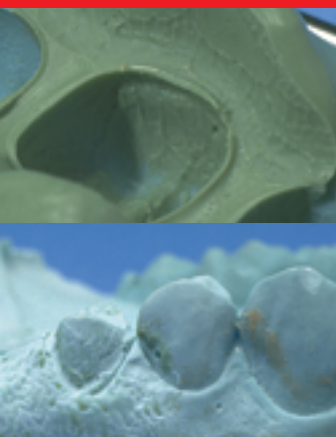
Photo #1 (top)

Surface Inhibition - Simult. Medium/Light Technique

■ The surface of the impression material is not set, tacky to the touch, and visually resembles the surface of an orange peel (Photo #1).

■ ■ Latex glove/rubber dam inhibition. Touching the prepared teeth or surrounding tissues, rolling retraction cord in gloved fingers, or the use of a rubber dam may transfer sulfur to critical areas of the impression; causing site specific inhibition.

■ ■ Exposure to residues from custom temporary materials.

■ ■ Exposure to air inhibited methacrylates (i.e., composites, adhesives, core build-up materials).

■ Wear vinyl gloves, or latex gloves which are proven not to inhibit the set of VPS impression materials. If contamination is suspected, scrub affected area with dilute hydrogen peroxide immediately prior to making the final impression.

■ ■ Fabricate the temporary crown or bridge after the final impression has been made.

■ ■ Remove air inhibited layer on the exposed surface with an alcohol wipe before making the final impression.
